ICPI TECH SPEC NUMBER • 7

Repair of Utility Cuts Using Interlocking Concrete Pavers

© 1996 ICPI Tech Spec No. 7 Interlocking Concrete Pavement Institute—Revised August 2001

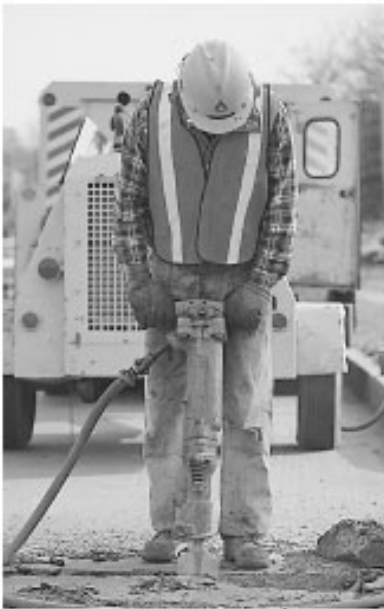
Figure 1. Repairs to utilities are a common sight in cities, incurring costs to cities and taxpayers.

North American cities have thousands of utility cuts made in their streets each year. Figure 1 shows a daily occurrence in most cities: repairs to underground utility lines for water, sewer, gas, electric, steam, phone, fiber-optic, or cable services. A sample is given below of the number of annual utility cuts in a few cities.

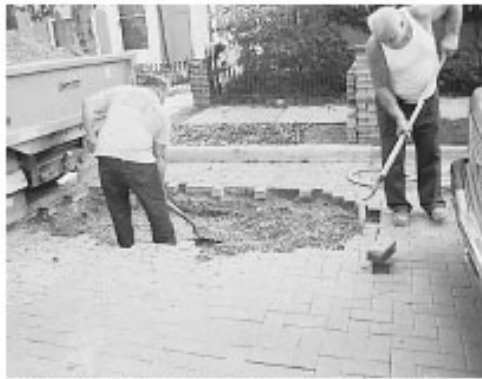
Figure 2. Removal of concrete pavers for a gas line repair in Dayton, Ohio.

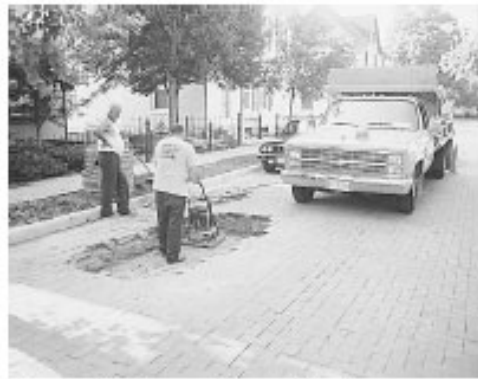
Figure 3. Compaction of the base.

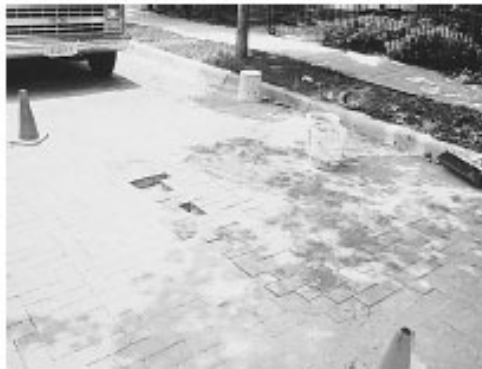
Figure 4. Reinstatement of the pavers, bedding and joint sand.

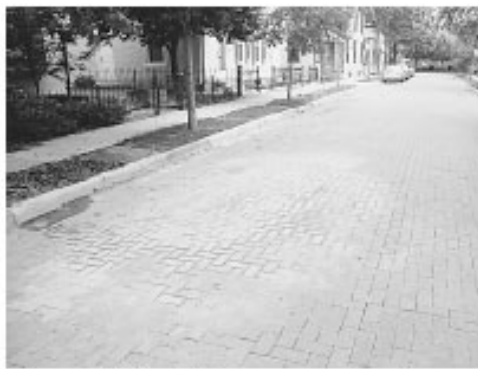
Figure 5. The final paver surface is continuous. There are no cuts or damage to the pavement.

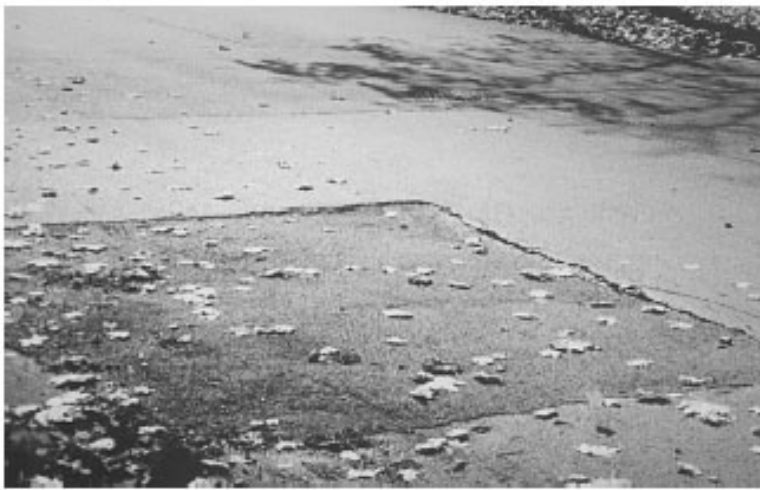
Figure 7. Pavement damage from settlement and shrinkage of cold patch asphalt.

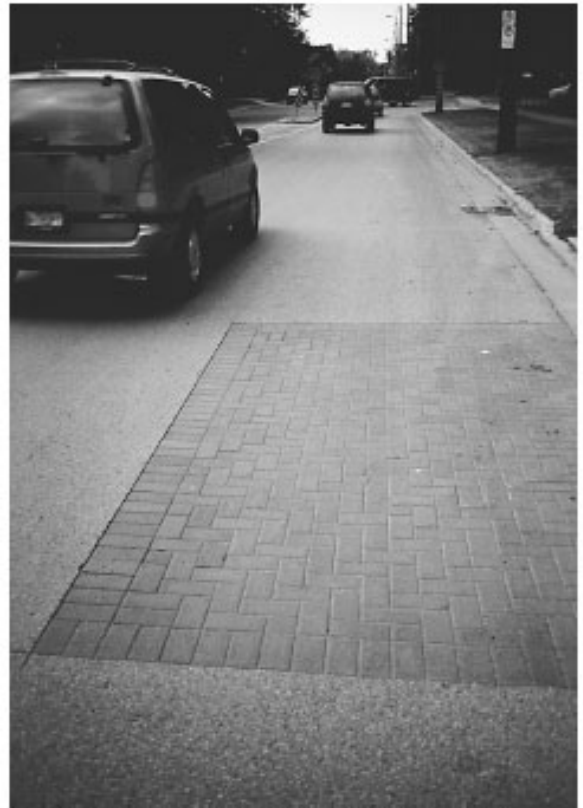
Figure 8. Utility cut repair in a residential area in London, Ontario.

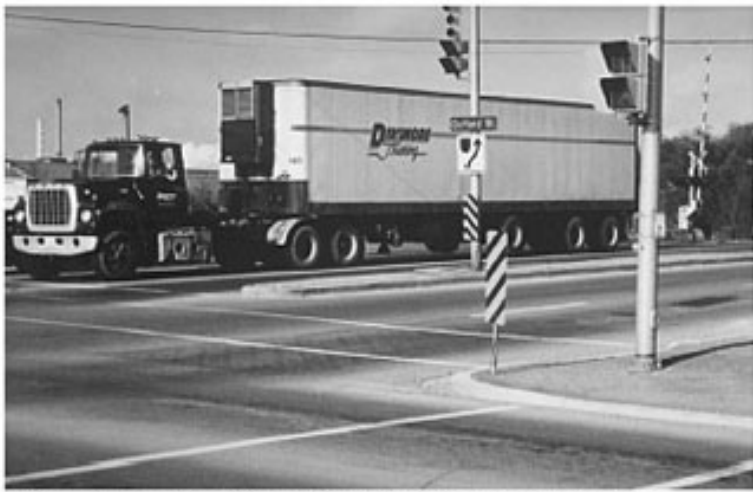
Figure 10. A patch of barely discernible pavers in a heavily trafficked intersection in London, Ontario.

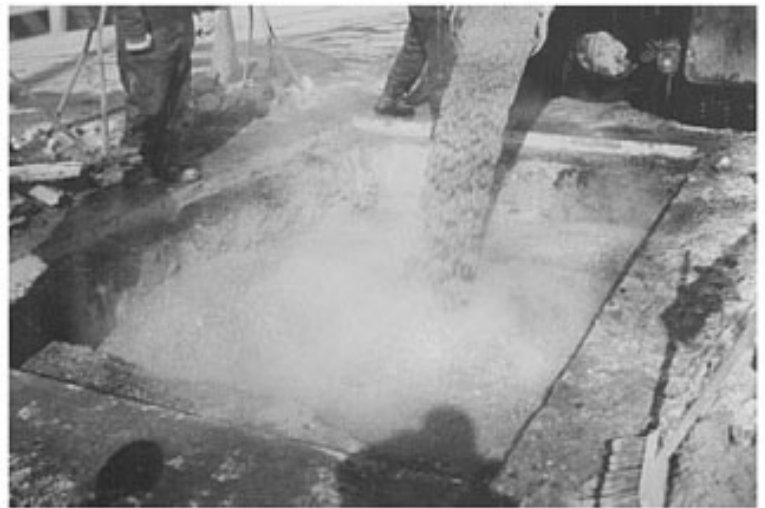
Figure 11. Low density concrete fill (unshrinkable fill) poured into a utility trench from a ready-mix concrete truck.

Unshrinkable fill poured into the trench is shown in Figure 11. The fill flows into undercuts, under the edge of the cut asphalt (providing additional support), and in places where the soil or base has fallen from the sides of the trench. These places are normally impossible to fill and compact with aggregate base or backfill material. There are many mixes used for low-density concrete fill (7) (8). Proprietary mixtures include those made with fly-ash that harden rapidly. Others are made with cement. A recommended mix can be made with ASTM C 150 (9) Type I Portland cement (or Type 3 for winter repairs), or CAN3-A23.5-M type 10 (or type 30 Portland cement) (10). The slump of the concrete should be between 6 and 8 in. (150 and 200 mm) as specified in ASTM C 143 (11) or CAN3A23.2.5C (10). When air entrainment is required to increase flowability, the total air content should be between 4 and 6% as measured in ASTM C 73 (11) or CAN3-A23.2-4C (10). Air content greater than 6% is not recommended as it may increase segregation of the mix. A strength of 10 psi (0.07 Mpa) should be achieved within 24 hours. The maximum 28 day compressive strength should not exceed 50 psi (0.4 Mpa) as measured by ASTM C 39 (11) or CAN3-A23.2-9C (10). Cement content should be no greater than 42 lbs/cy (25 kg/m³). The low maximum cement content and strength enables the material to be excavated in the future. Mixes containing supplementary cementing materials should be evaluated for excessive strength after 28 days.

Repaired utility lines are typically wrapped in plastic prior to pouring the low density fill. This keeps the concrete from bonding to the lines and enables them to move independently. When the fill is poured, it is self-leveling. It should be poured to within 4 in. (100 mm) of the riding surface of the asphalt.

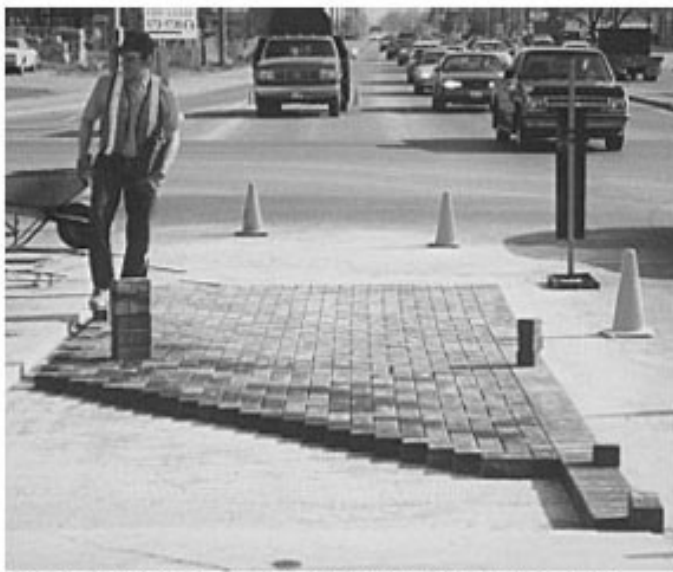
Figure 12. Pavers are laid in a 90 degree herringbone pattern between the border courses.

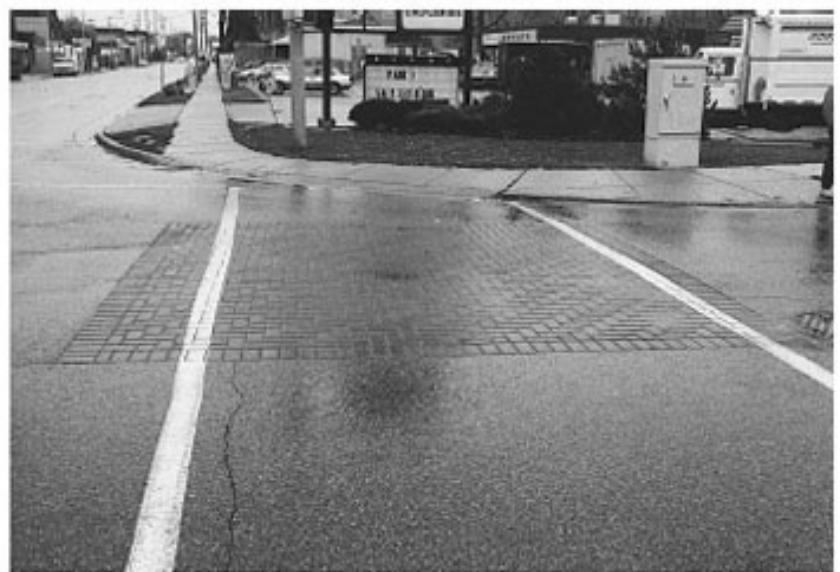
Figure 13. Concrete pavers in utility cuts can be painted as any other pavement.

Concrete pavers should be at least 3.125 in. (80 mm) thick and meet the standards in ASTM C 936 (12) or CSA A231.2 (13). They should be delivered in strapped bundles and placed around the opening in locations that don't interfere with excavation equipment or ready-mix trucks. The bundles should be covered with plastic to prevent water from freezing them together. The bundles need to be placed in locations close to the edge of the opening. Most bundles have several rows or bands of pavers strapped together. These are typically removed with a paver cart. The paver bundles should be oriented so that removal of the bands with carts is done away from the edge of the asphalt. Rectangular concrete pavers [nominally 4 in. by 8 in. (100 mm x 200 mm)] should be placed against the cut asphalt sides as a border course. They should be placed in a sailor course, i.e., the long side against the asphalt. No cut paver should be smaller than one third of a unit. Place pavers between the border course in a 90 degree herringbone pattern (Figure 12). Joints between pavers should not exceed 1 / 16 in. (2 mm). Compact the pavers with a minimum 5,000 lbf (22 kN) plate compactor. Make at least two passes with the plate compactor. A small test area of pavers may need to be compacted to check the amount of settlement. The bedding sand thickness should be adjusted in thickness to yield pavers no higher than 1 / 8 in. (3 mm) above the edge of the asphalt. Spread, sweep and compact sand into the joints. The joint sand is typically finer than the bedding sand, and should conform to the grading requirements of ASTM C 144 (11) or CSA A179 (10). The joints must be completely full of sand after compaction. Remove excess sand and other debris. The pavers may be painted with the same lane, traffic, or crosswalk markings as any other concrete pavements (Figure 13).
